Light leaks in scintillator wrapping paper caused by tiny holes

R. Armendariz – 2024

QCC Physics

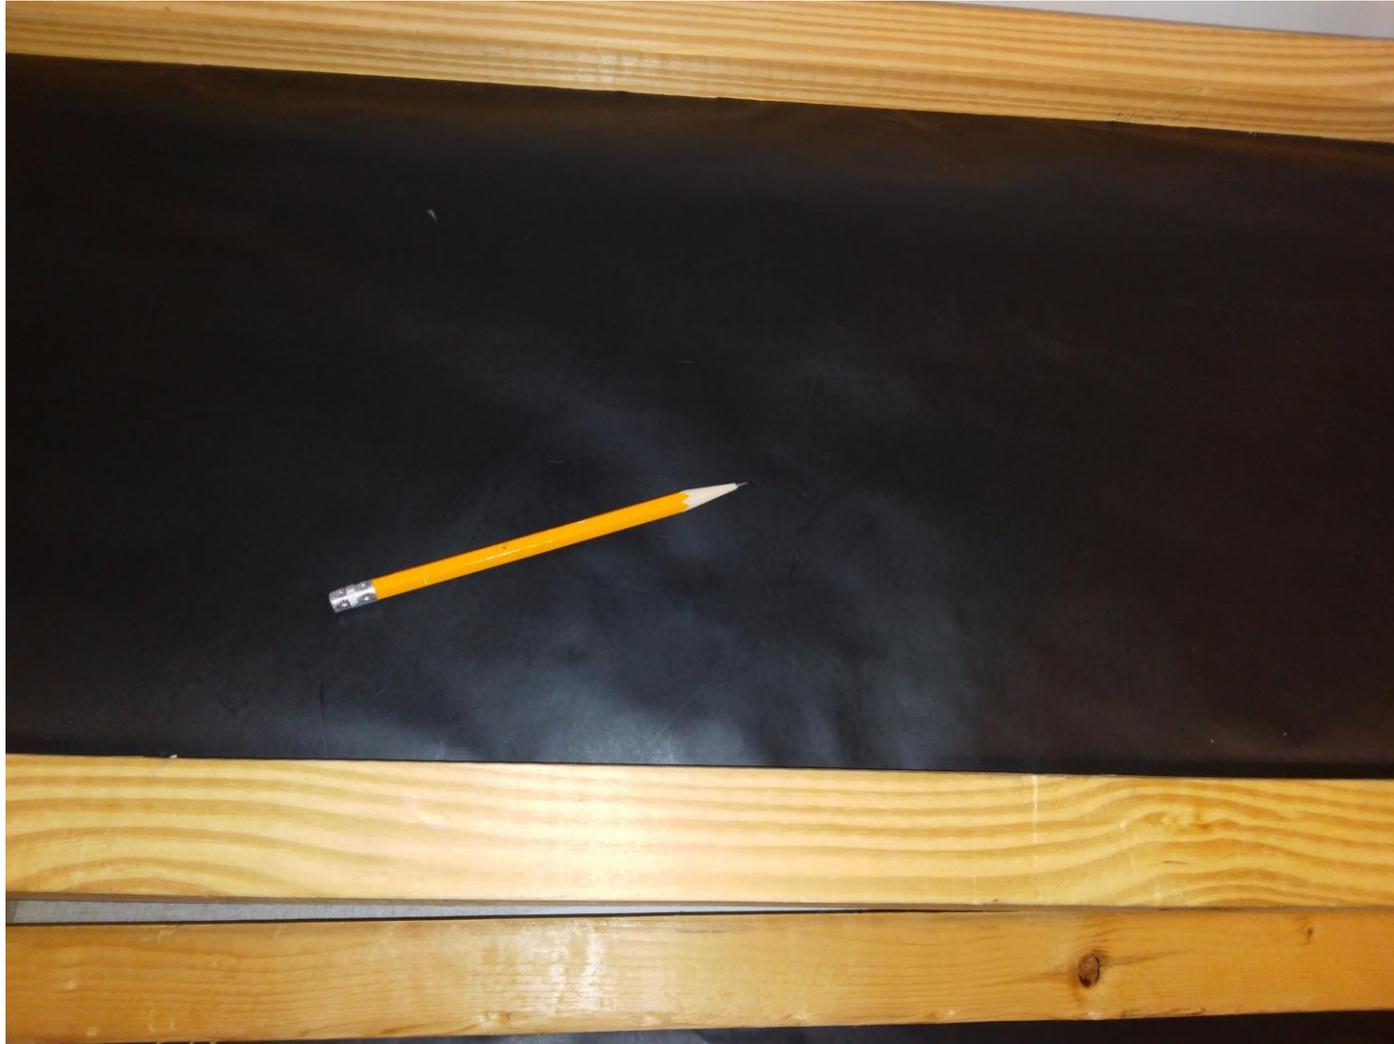
In the picture the pencil tip is pointing to a 1 mm size hole in the black paper covering the plastic scintillator. At first the hole only looked like an indentation, but it turned out to be a huge light leak problem which would have introduced a lot of noise in the cosmic ray data

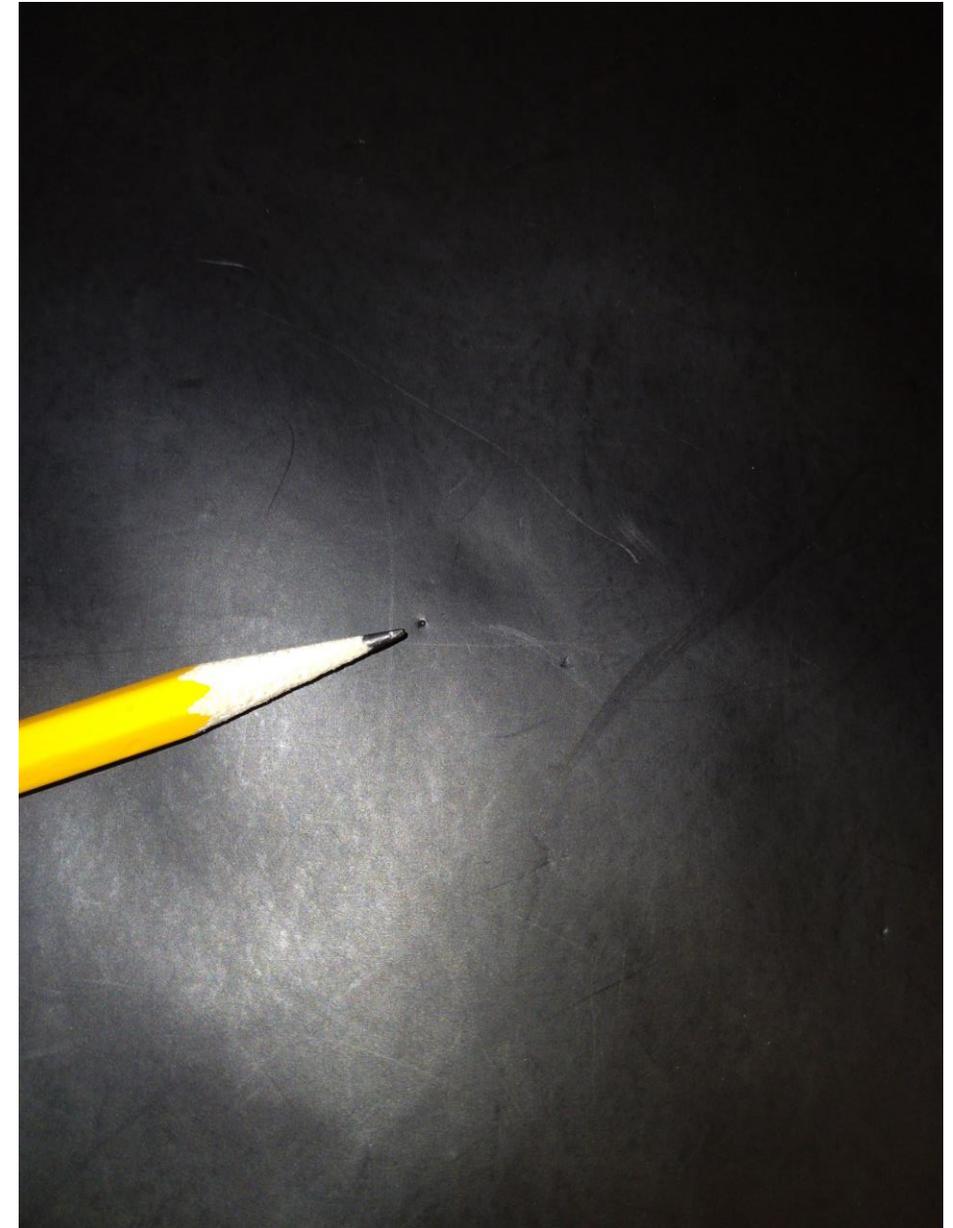
A pmt was mated to the end of the scintillator (outside of the picture), and the pmt output was connected to an oscilloscope. Shining a flashlight over the little hole caused the noise rate to increase from 6.4 kHz to 3 MHz!

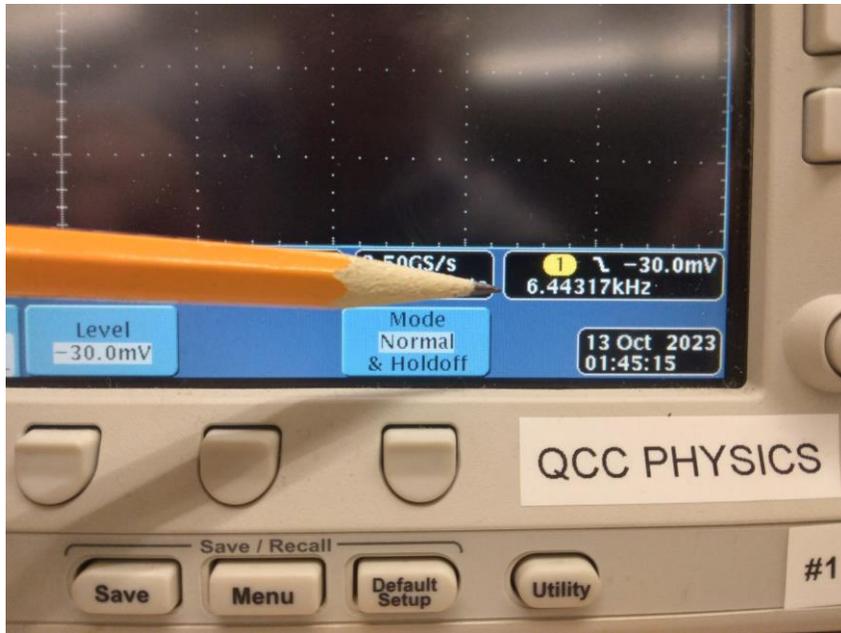
When the flashlight was not shining over the hole the noise rate measured 6.4 kHz on the oscilloscope

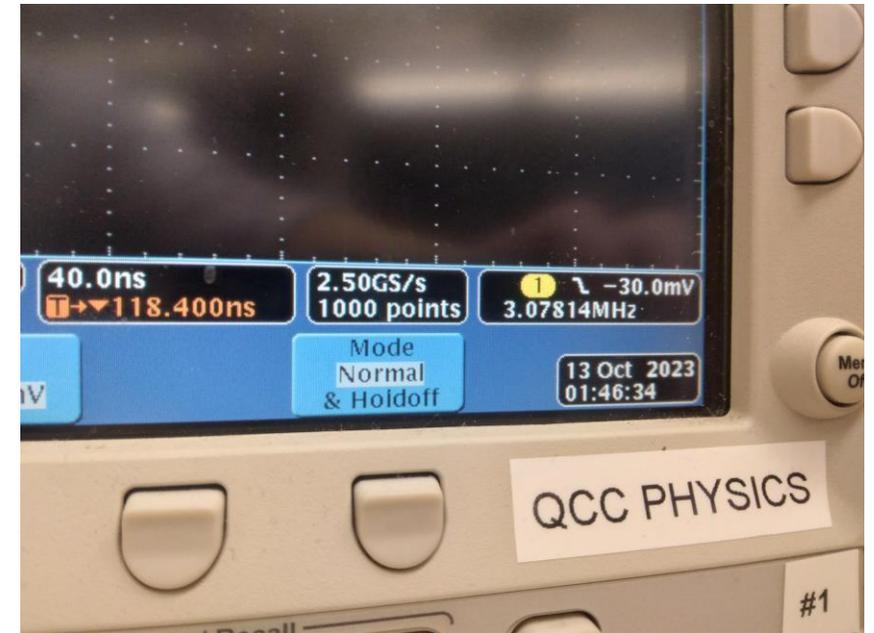
When the flashlight was shining over the hole the noise rate measured 3 MHz on the oscilloscope
