Light leaks in scintillator wrapping paper caused by tiny holes

R. Armendariz – 2024

QCC Physics

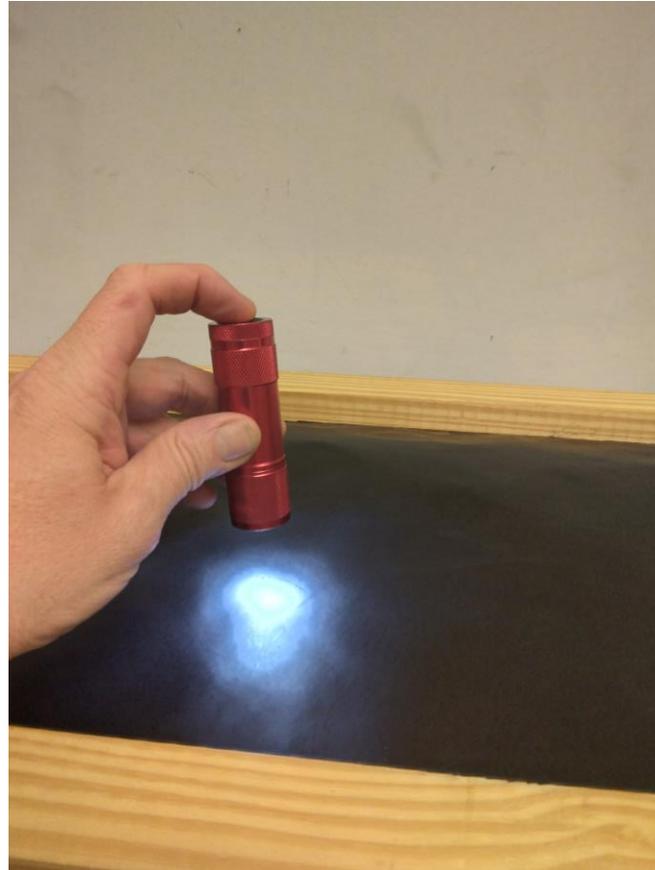
A pmt was mated to the end of the scintillator (outside of the picture), and the pmt output was connected to an oscilloscope. Shining a flashlight over the little hole caused the noise rate to increase from 6.4 kHz to 3 MHz!

When the flashlight was shining over the hole the noise rate measured 3 MHz on the oscilloscope
